CIVIL AERONAUTICS BOARD

ACCIDENT INVESTIGATION REPORT

CONTINENTAL CHARTERS, INC., NEAR LITTLE VALLEY, NEW YORK
DECEMBER 29, 1951

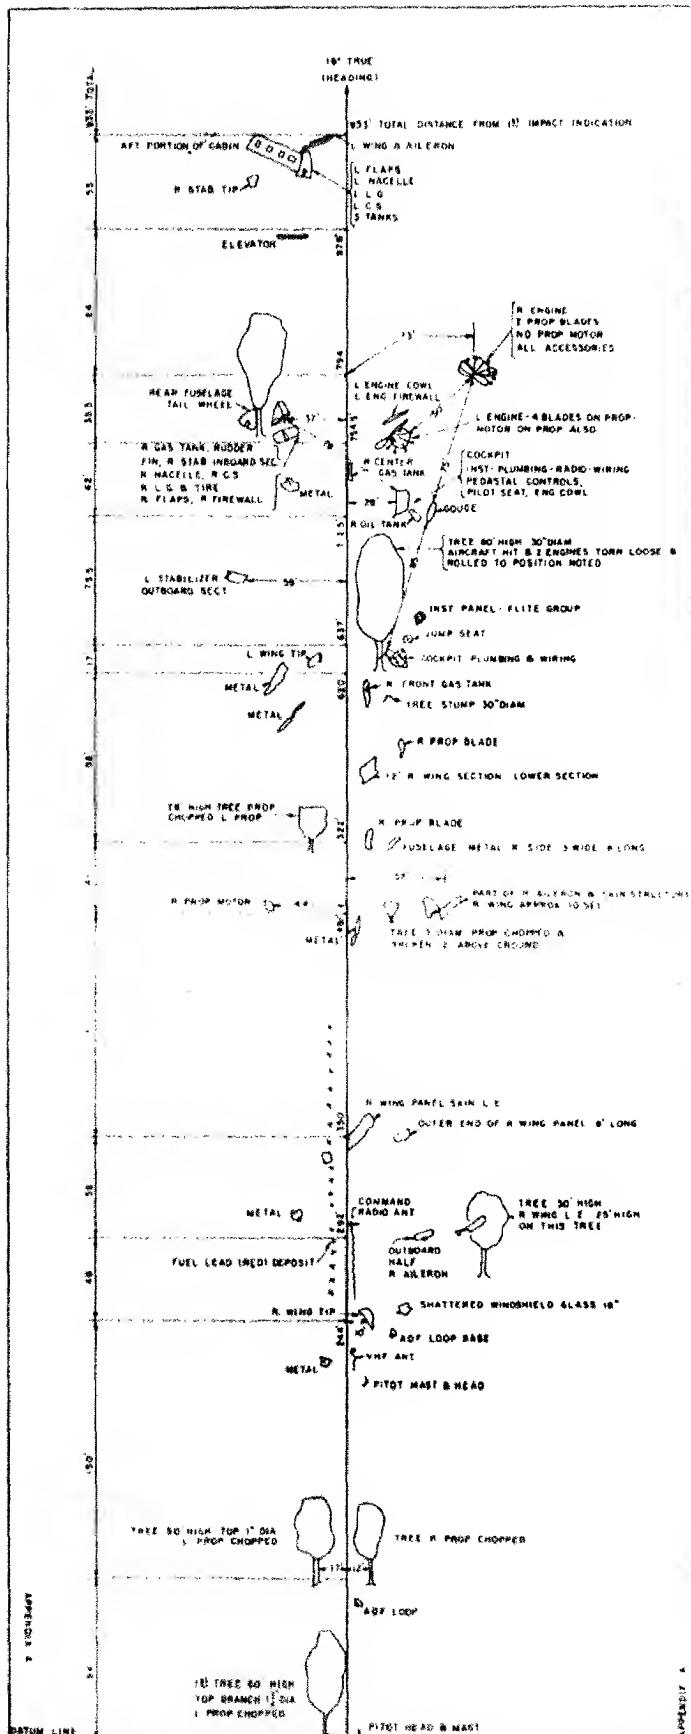
APPENDIX A

Investigation at the scene indicated that the accident occurred about 100 feet below the crest of a hill, at an altitude of 2375 feet MSL, while the aircraft was in level flight and on a true heading of approximately 18°. Indications were that first contact was with small branches of a tree 60 feet above the ground. From this point on, as forward travel continued, disintegration of the aircraft progressed along a path 933 feet beyond the point of initial impact. All major components were accounted for along this path. Disintegration of the aircraft was complete with the exception of the aft part of the passenger compartment which came to rest at the most distant end of the line of travel.² It was in this section that

DISTRIBUTION OF AIRCRAFT WRECKAGE
ALL WRECKAGE SHOWN IS IN DENSE WOODED AREA
"DRAWING NOT TO SCALE"
